## NEW MEXICO MAINSTREET PROGRAM

## RESOURCE TEAM ASSESSMENT

## Mountainair Broadway Fire Impacts and Strategies

### **Mountainair Site Visit Report The Weaver Hotel 112 W. Broadway**

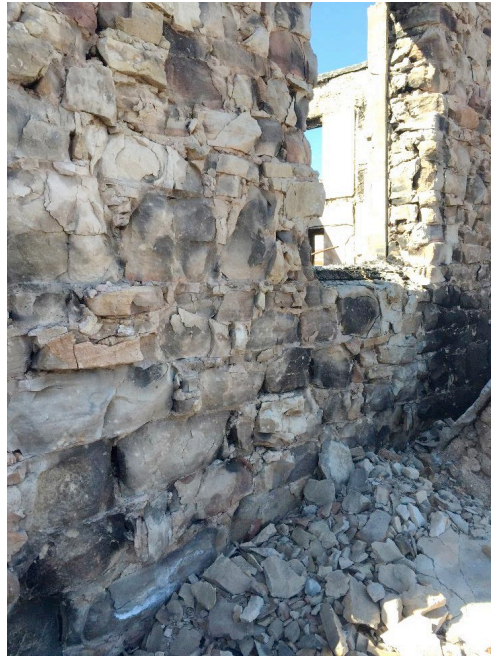
The remaining exterior walls are severely compromised due to: 1) weakened masonry structural strength from fire and heat exposure to bricks and mortar, 2) loose and fallen stone, 3) unpinned lateral support due to absence of roof and floor framing, and 4) insufficient load paths due to missing components or improper original design. Of significant concern are the east wall and east sections of the north and south walls heavily damaged from heat due to the proximity of the origin of the fire. The heat has cracked the sandstone and significant spalling has occurred.

*Figure 1. Photograph of exterior of east wall showing delaminated and fallen sandstone. Photo also shows random sizing and bonds of stonework.*

If the desire is to restore or rehabilitate these walls, significant repointing and reworking of the stone must be done from the interior and exterior. The wall thickness contains layers of stone, not laid in distinct wythes.

This work would have to occur over all areas of the east wall and the majority of the north and south walls. The west wall requires less area. Careful excavation and reinsertion of loose, missing, or cracked stones and mortar in prescribed sequential sectioned areas and preferably in a checkerboard pattern, should be accomplished by a qualified, licensed mason experienced in historic restoration work. Existing sandstone (maintaining structural integrity) should be used to the extent possible with a mortar designed to match the constituents of the historic mortar.

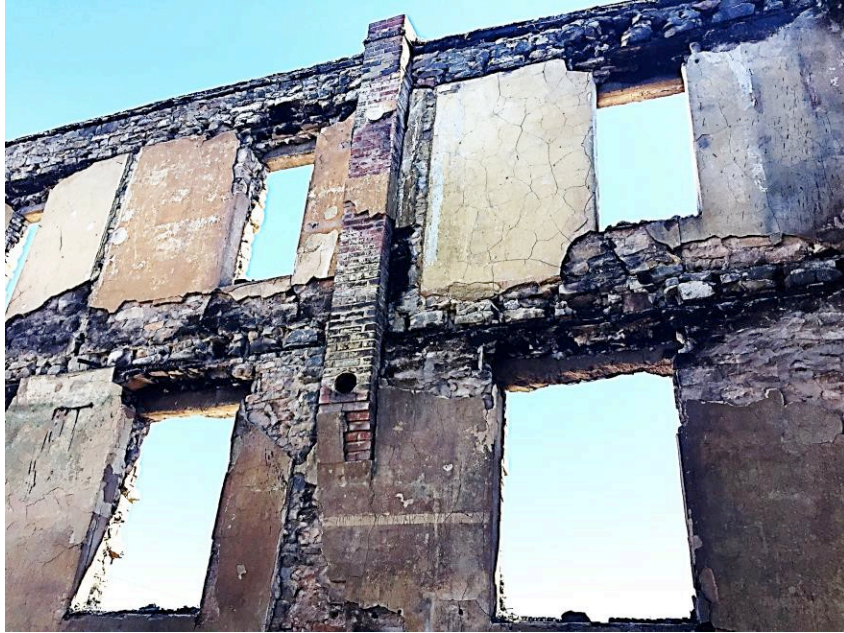
*Figure 2. Photo of interior of east wall showing remnants of interior plaster, joist pockets, stove chimney, and burned interior lintels.*

sufficiently sized lintels at the openings with proper bearing length to adequately transfer loads around the openings without stressing narrow columns of stone adjacent to the openings.

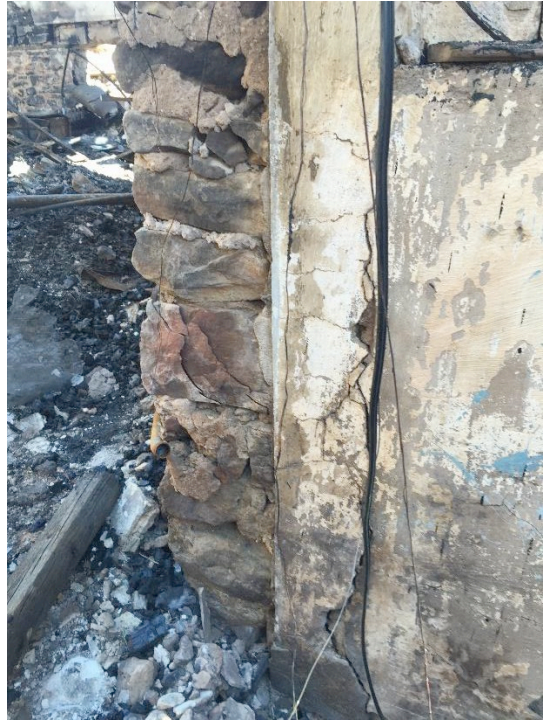
*Figure 3. Detail of section through 1<sup>st</sup> floor window showing cracked stone and plaster.*

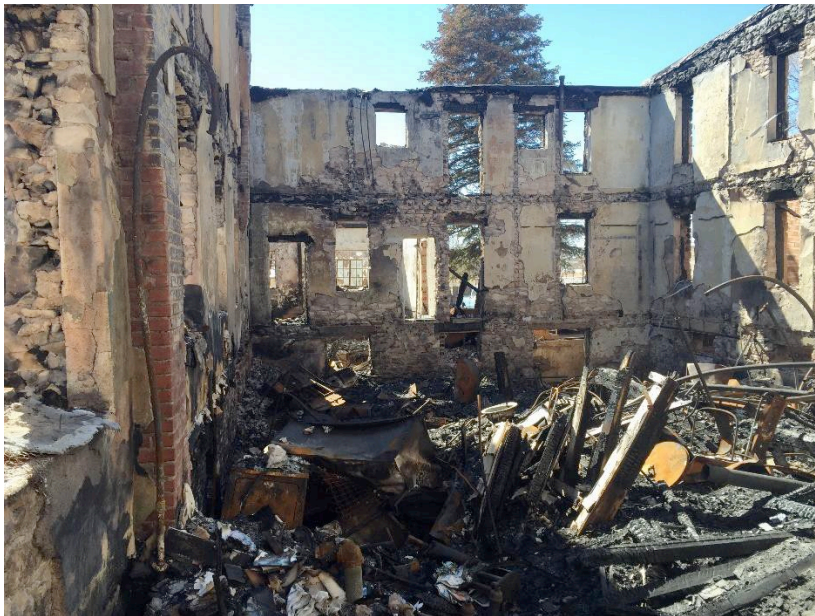
*Figure 4. View of interior looking south*

The wall height and wall length to thickness ratio requires lateral support in the horizontal and vertical direction. The total unsupported height and length were not measured on site. The International Building Code stipulates a 20:1 height or length to thickness ratio. At a minimum, a reconstruction of the roof, floor at original first floor level, and interior walls to meet the horizontal code requirement, are recommended. The cost for the above work will be significant.

Another option could include construction of a structural frame within the stone walls. This frame would be designed to withstand applied loads for the new use of the building, and support the stone walls. This option would lessen the requirement of totally reworking and repointing some wall sections, and lateral support requirements. Stonework would still have to be stabilized.

Probably the most favorable approach in terms of cost is to raze the east wall, corners, and east sections of the north and south walls, and reconstruct these areas. This option would allow better access for debris removal.

All options above require shoring of walls as soon as possible. Shoring and debris removal must be carefully designed and performed by a qualified licensed shoring/demolition contractor. The bracing design shall not use an anchoring system that requires an impact or blow to the wall. Danger signs shall be placed in conspicuous locations either on the wall or anywhere within the collapse area. The danger signs shall be maintained in place and in a legible condition until the masonry wall is permanently supported.

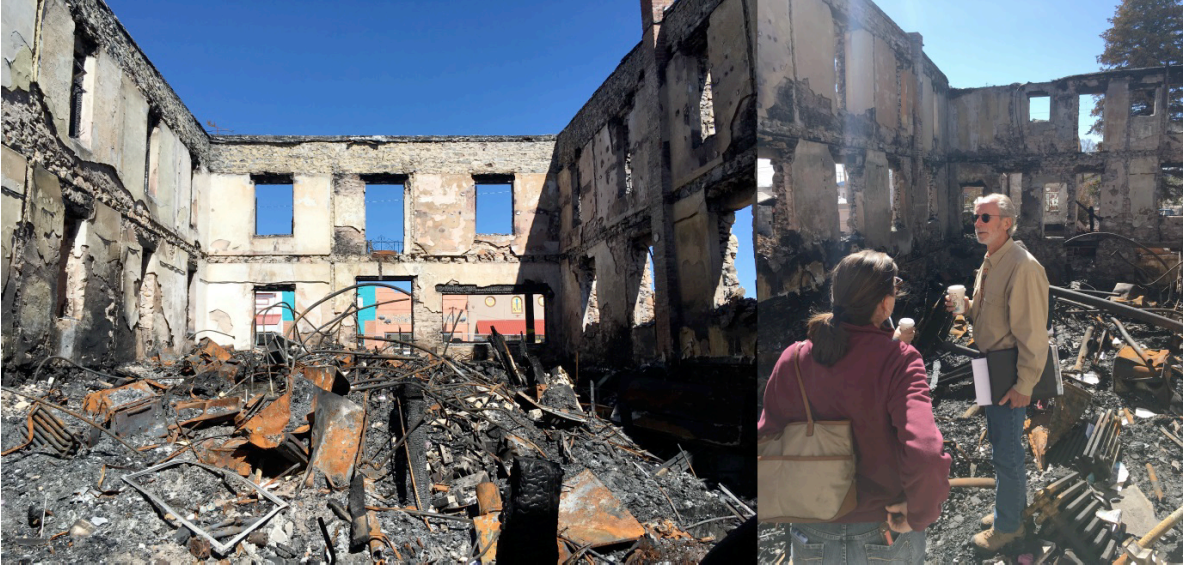
*Interior view of the Weaver Hotel, looking towards front of building; Sonya Cooper 7 Charlie Deans standing in the ruins fo the Weaver Hotel*

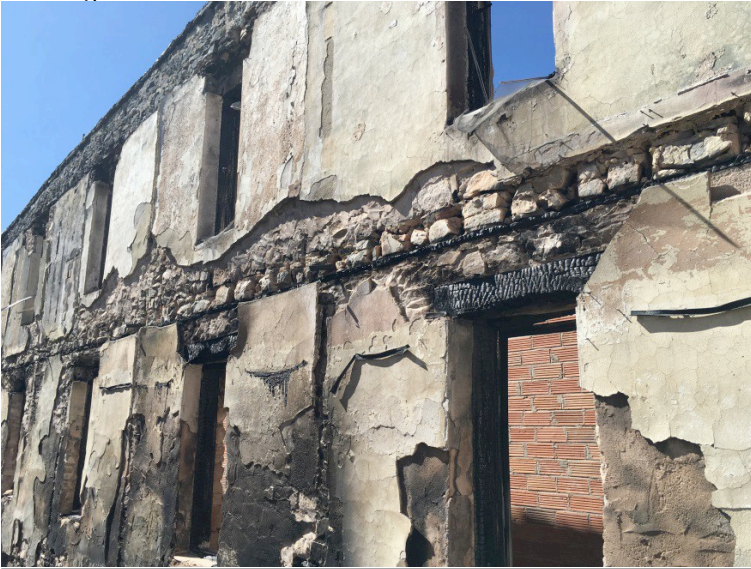
*Weaver Hotel, interior view of west wall*

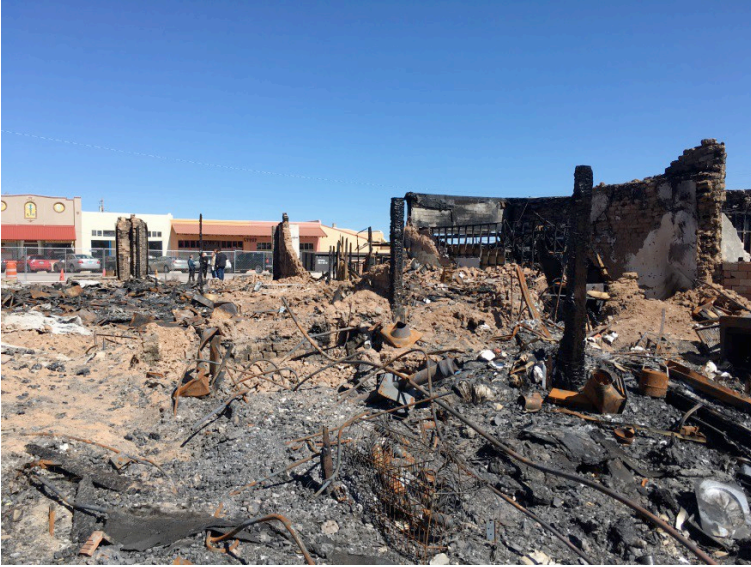
*Interior view of Uncle Walter's Thrift Store*

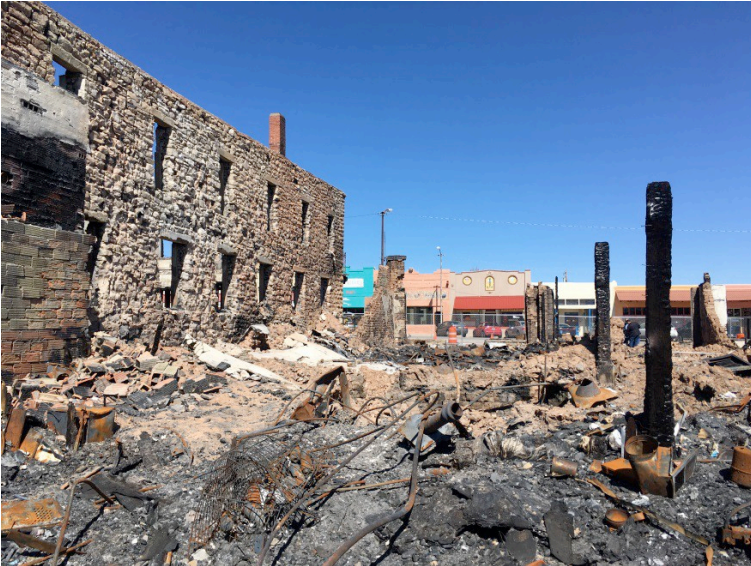
*Interior view of The Emporium*

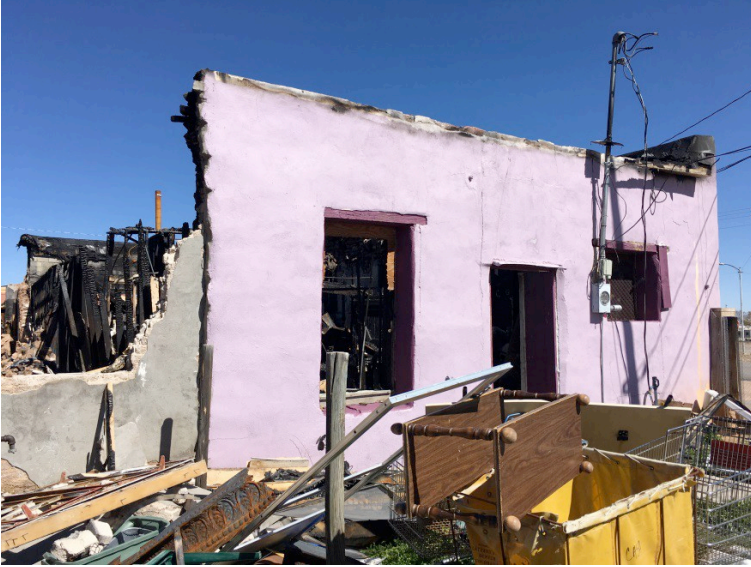
*View of rear wall, Uncle Walter's Thrift Store*

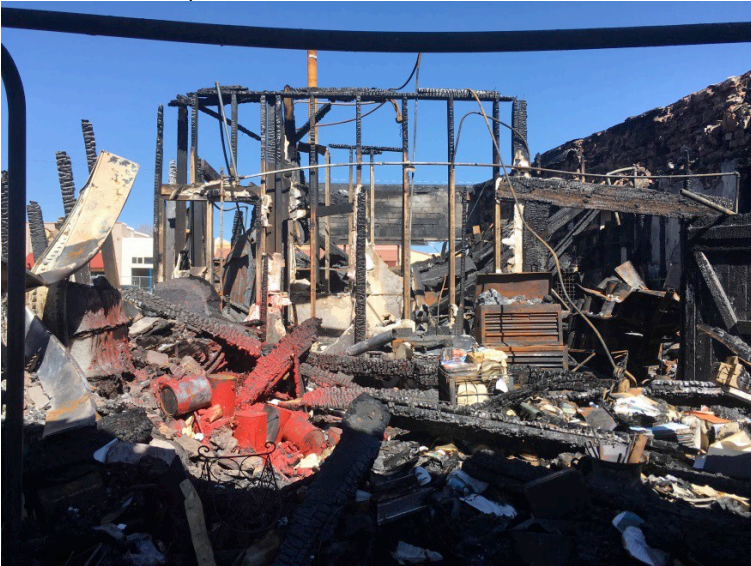
*Interior view, Uncle Walter's Thrift Store*

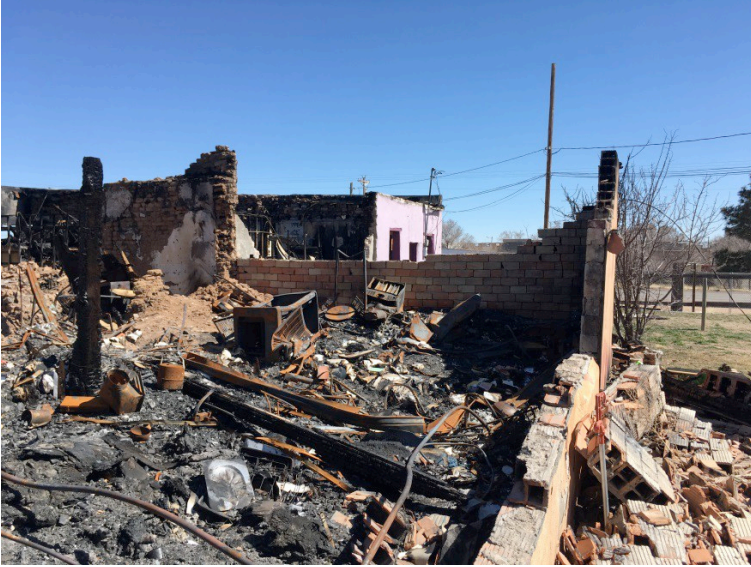
*Interior view of The Emporium at the back of the store*
